Understanding Package Crack Signatures in a Leadframe Semiconductor Package

Original Research Article

ABSTRACT

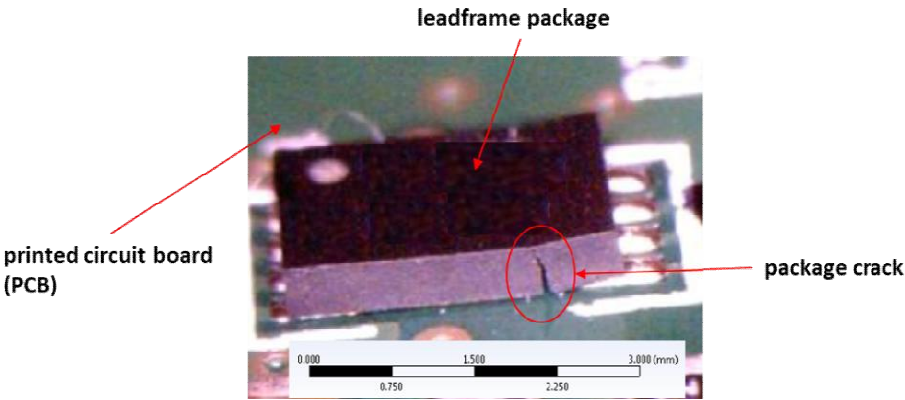
Fig. 1 shows an actual package crack problem from a customer complaint in a leadframe semiconductor package. Here, it is not clear where this could happen and what causes this kind of package crack. It could be that the package already has some small or hairline crack before it is mounted on the PCB. It could also be that this crack is induced during the mounting of the package. Without understanding the distinct package crack signatures, it would be very difficult and time consuming to find the real root cause. Then, there would be a possibility

With the crack signatures identified for the different mechanical loading scenarios simulated in a laboratory experimental setup, identifying the root cause would now be easier and faster. Going back to the package crack signature of the original problem reported (Fig. 1) and comparing with the distinct crack signatures from the simulated loading to the package, it can be observed that the package crack is very similar to the crack produced with the loading condition simulated in Fig. 6b with crack signature shown in Fig. 11. This means that the crack happens with the leadframe package soldered to the PCB and an external force is applied causing bending and then package crack because the exposed die pad is not soldered and supported against bending. The solution was then to solder the exposed die pad and control the amount of external force applied to the package mounted on PCB.

Fig. 1. Package crack in a leadframe package mounted on PCB

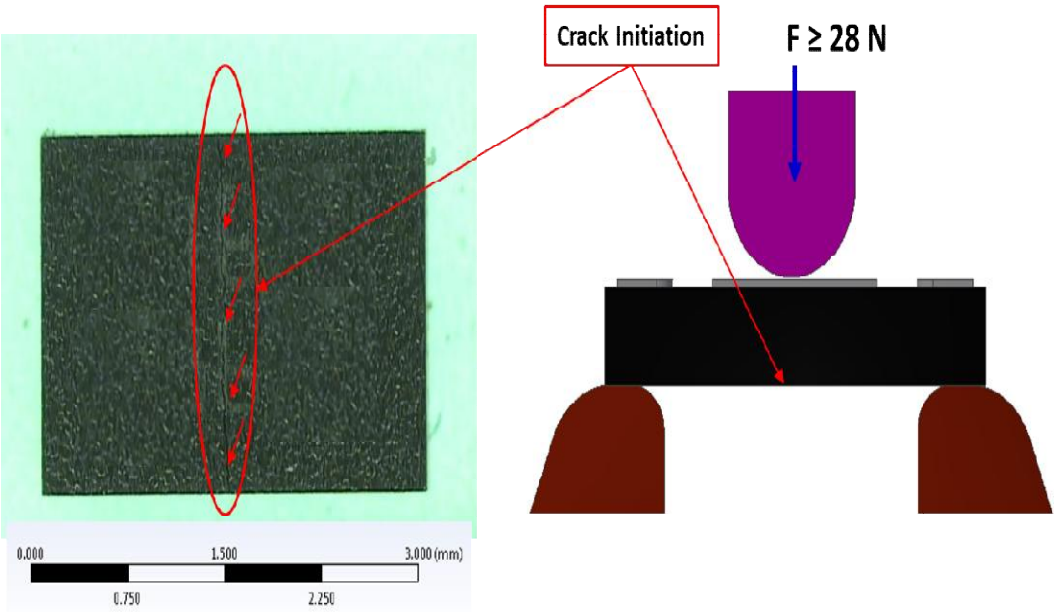
For the first loading scenario in Fig. 5a, the package crack propagates from the top of the package (resin side) and is located at the package centerline as shown in Fig. 7. The breaking force or the force at which the package breaks in this loading condition starts at 28 N.

Fig. 7. Crack signatures for the tested package not mounted on PCB in Fig. 5a

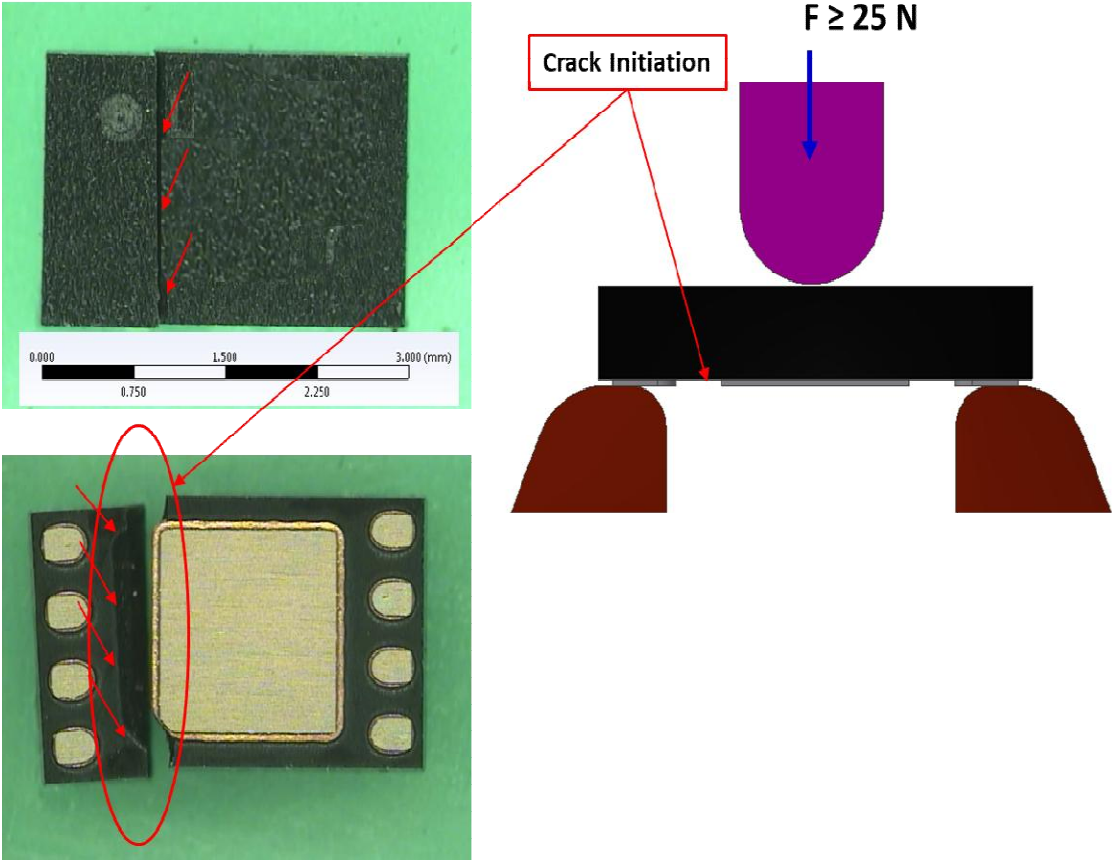
For the next loading scenario illustrated in Fig. 5b where force is applied to the resin side, the crack is now located at the die pad edge and it propagates from the bottom or the lead side to the top or the resin side (Fig. 8). The breaking force is a bit lower compared to the one in Fig. 7, where the resin side is facing downward. It appears that there is some weakening at the leadframe pad/mold intersection (leadframe side), which is subjected to tensile stress in this loading condition resulting in some reduction in force required to break the package.

Fig. 8. Crack signatures for the tested package not mounted on PCB in Fig. 5b

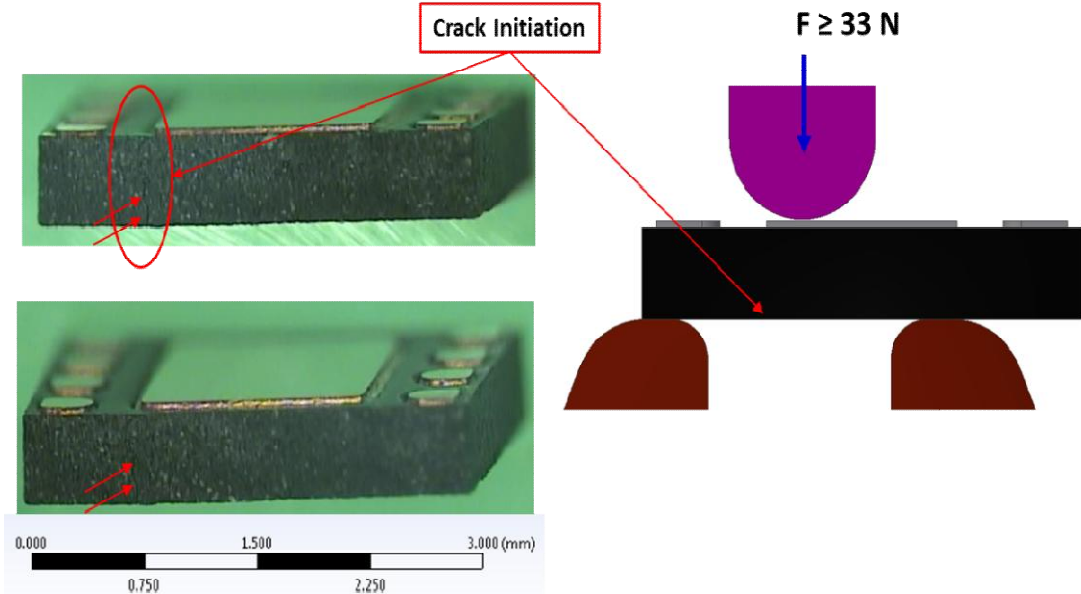
With the offset loading of the package in Fig. 5c, the package crack is still located at the die pad edge. However, the crack propagation is now going in the opposite direction, that is from the resin side to the lead side as shown Fig. 9. The breaking force is higher in this loading condition compared to the two previous conditions since the distance between the two anvil supports is now shorter.

Fig. 9. Crack signatures for the tested package not mounted on PCB in Fig. 5c

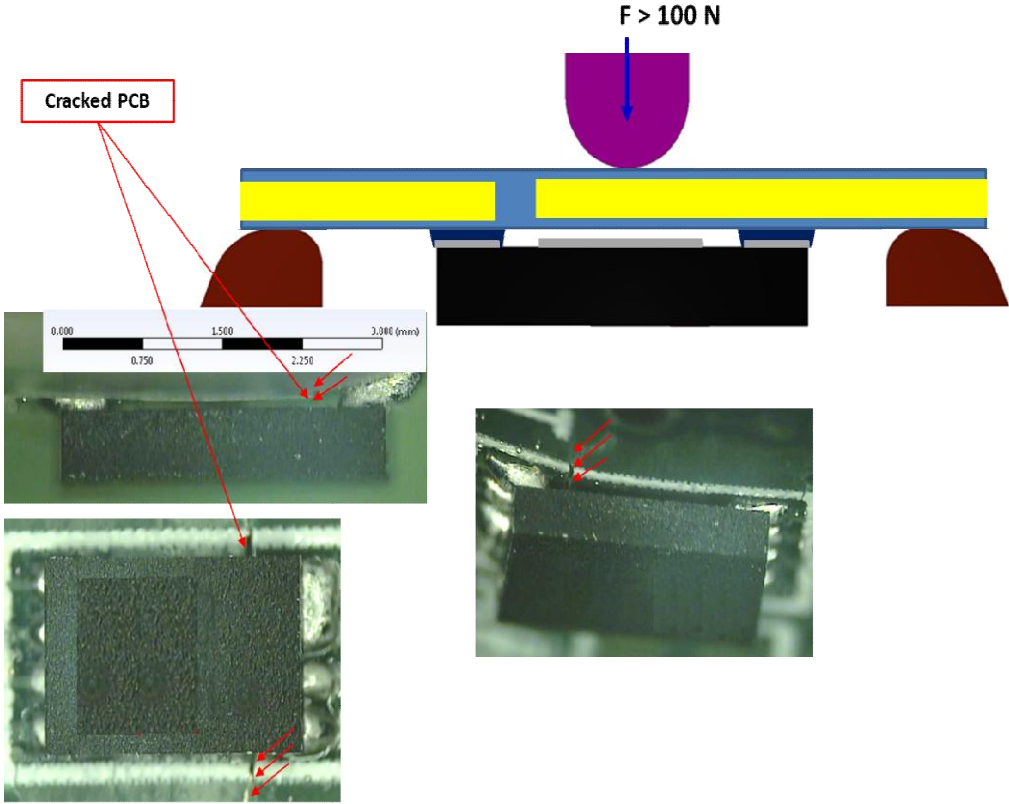
The resulting package crack for the first loading condition on a board-mounted package is shown in Fig. 10. The board or PCB is already cracked

or damaged due to the bending force but the package is still intact. There is no damage to the soldered leadframe package and even to the solder joint. The force (>100 N) is already very high, but the package did not have any crack.

Fig. 10. Crack signatures for the tested package soldered on PCB in Fig. 6a

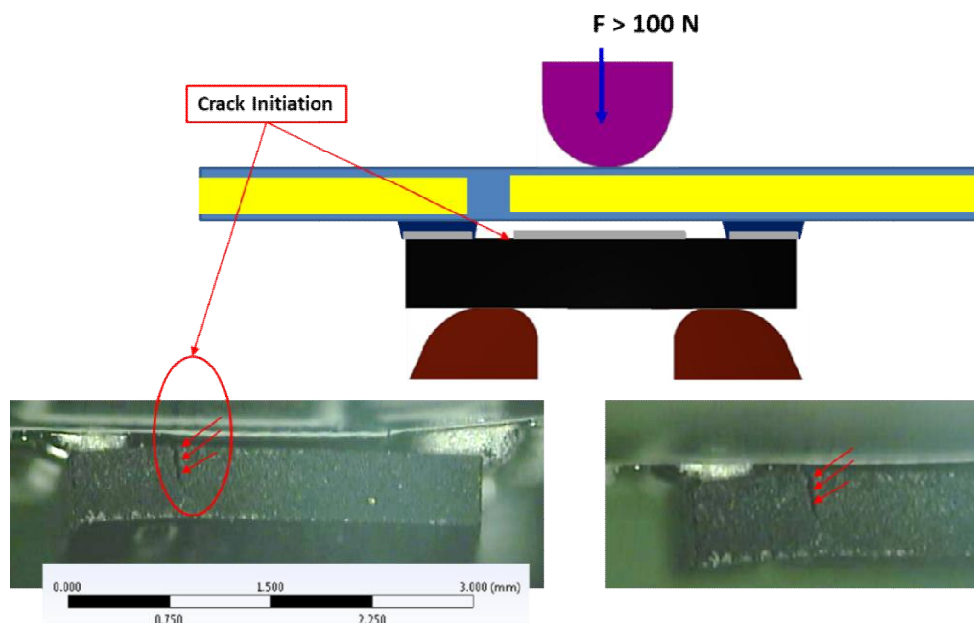
On the other hand, the crack is located at the die pad edge and propagates from the leadframe side of the package to the resin side (Fig. 11) for the loading condition illustrated in Fig. 6b. This happens because the exposed die pad is not soldered to the PCB and the force applied is causing the package to bend as the center of the package is not supported. It also needs much higher force (>100 N) to produce such crack in this loading condition since the location of the two anvil supports is close to the soldered lead. If the PCB with the soldered package is flipped such that the force is applied to the center of the package (resin side) and the PCB supported at the bottom by the two anvils, then the same package bending and crack signature would also be produced. The breaking force would then be much lower and close to the 25 N value obtained in Fig. 8 because the loading is now similar to Fig. 5b except that the package is soldered to the PCB.

Fig. 11. Crack signatures for the tested package soldered on PCB in Fig. 6b

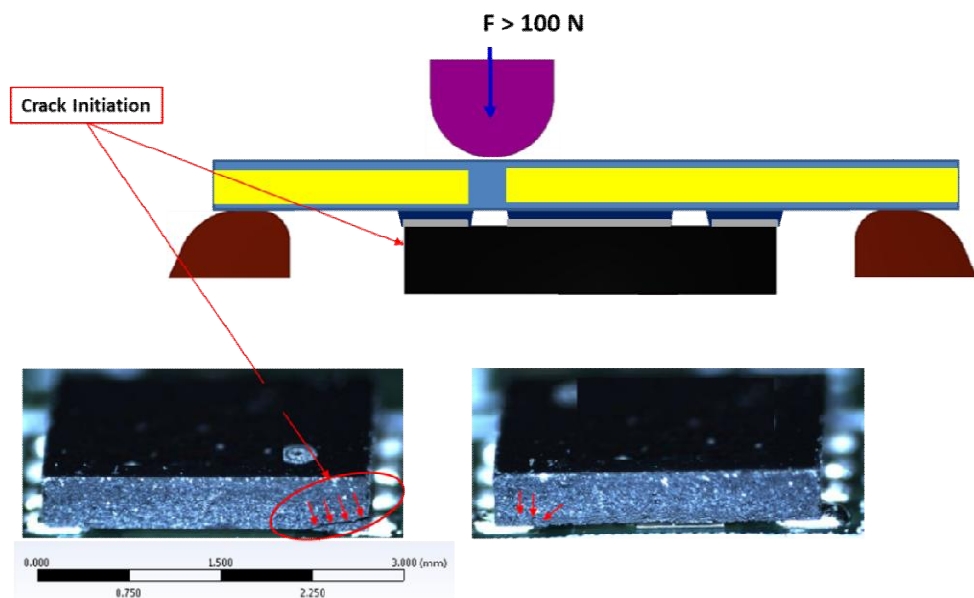
For the offset loading on board-mounted package, the resulting crack is located at the lead or solder joint area as shown in Fig. 12. That area appears to be weaker than the resin area where the crack initiated in the case of the offset loading with the package not mounted on board (Fig. 9). The breaking force remains high in this loading condition.

Fig. 12. Crack signatures for the tested package soldered on PCB in Fig. 6c
