Aircraft Brake Dust Dispersion (Airwash) Testing

Abstract

Aircraft, Brakes, Asbestos, Airwash

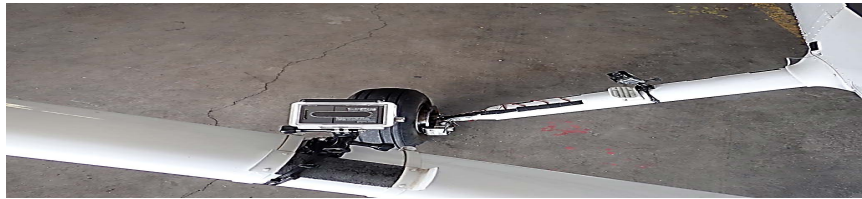
Figure 1. Right main wheel brake assembly.

For this research, a 1998 Cessna, model 172R was outfitted with video cameras that recorded multiple views of the aircraft's right main wheel brake assembly (**Figure 1**), along with the right-seat passenger's view (**Figure 2**).

At no time was any visible dust observed emanating from the right brake caliper. Also, post-flight brake inspection showed no dust accumulation either on the top or bottom surfaces of the brake caliper. Any wear dust generated during the braking process was released into the turbulent airstream and did not accumulate on the brake assembly or its component parts.

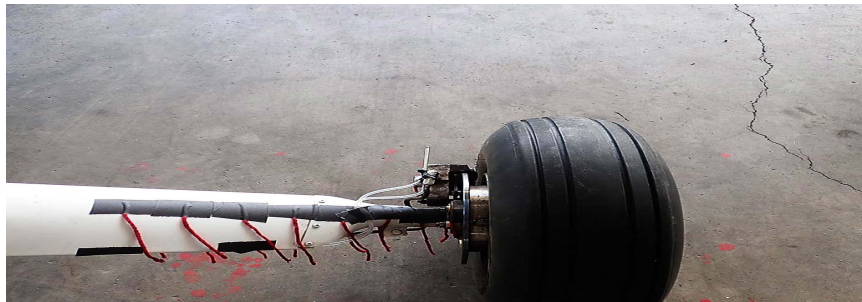
Figure 3. Instrumentation and telltale's record attitude and airspeed.

Instrumentation and telltales were installed that measured and recorded aircraft attitude and airspeed around the brake assemblies, along with relative wind directions (**Figure 3**).

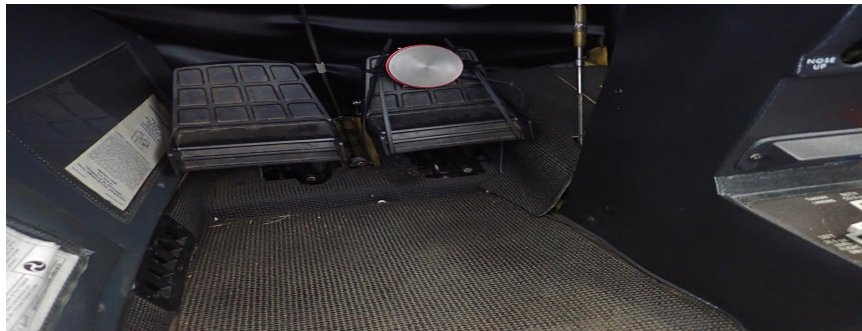
Figure 4. Brake force measured and recorded.

Applied brake force was also measured and recorded (**Figure 4**), and Global Positioning System (GPS) data were utilized to record the aircraft's flight path (**Figure 5**).

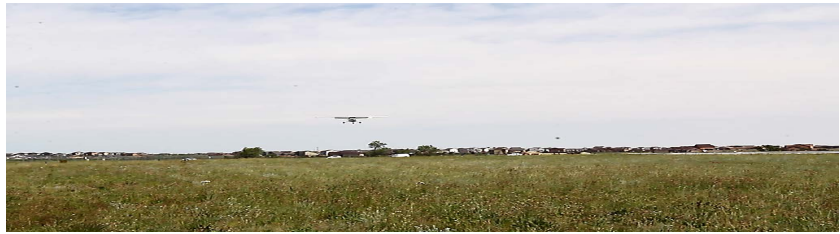
Figure 6. Video recording aircraft operations and landing.

A ground-based video camera was used to record aircraft operations, with primary focus on landings (**Figure 6**).
